Manhole Inspection Summary

Manhole # S41A1_006MH

Insp Date: **12/18/08 11:05 AM**

Location Address: **Tyco Admin Building**

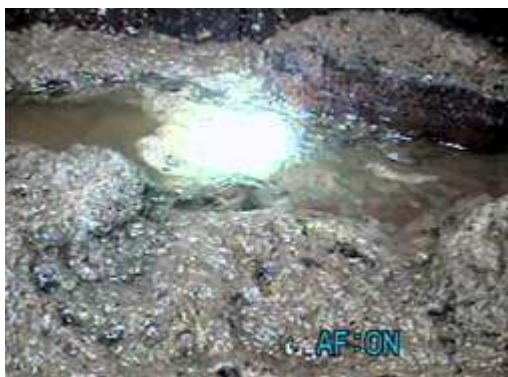
Defect 5

Condition: ☐ Sound ☐ Cracked ☐ Root Intrusion ☐ Deteriorated ☐ Leaks ☒ **Debris**

channel debris and amount of flow from infiltration in barrel

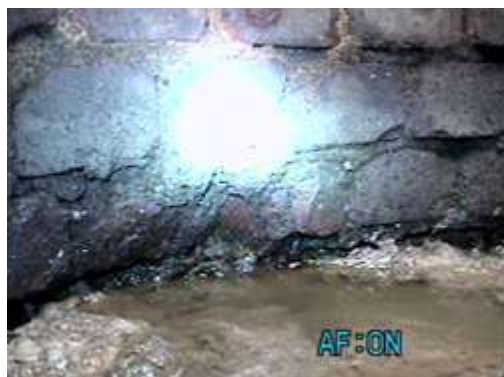
Defect 4

Infiltration: ☐ None ☒ **Joint** ☐ Cracks ☐ Mortar ☐ Roots ☒ **Wall**

barrel infiltration

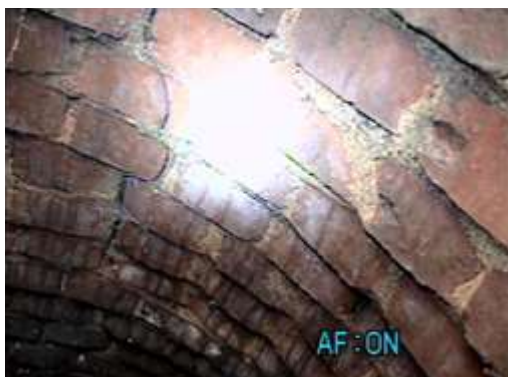
Defect 3

Condition: ☐ Sound ☒ **Cracked** ☐ Root Intrusion ☐ Loose Brick ☐ Deteriorated

corbel cracked wall

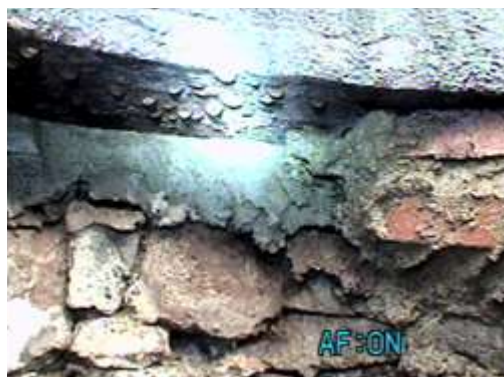
Defect 2

Condition: ☐ Sound ☒ **Cracked** ☐ Root Intrusion ☒ **Loose Brick** ☐ Deteriorated

chimney crack and deteriorated, frame adj

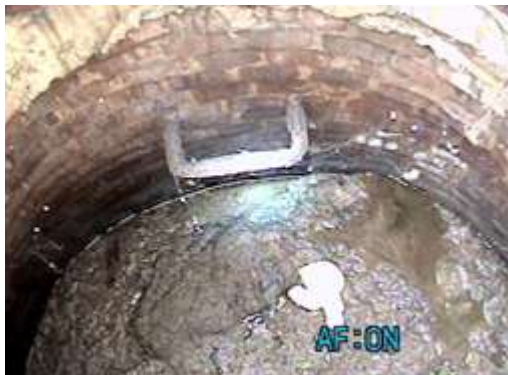
Defect 1

Count: **1** Missing: **0** ☒ **Corroded**

steps corroded

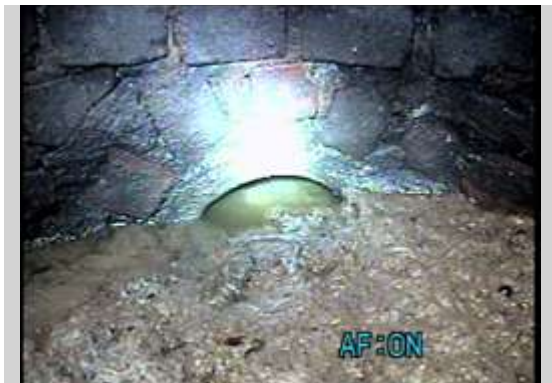
12 O'Clock Outflow

6 in. Circular Gravity Sewer
Pipe Out @ 12 O'Clock

Deposits: ☐ None ☐ Mud ☒ **Sludge** ☐ Debris ☐ Grease

Silt Depth: **0** (in.) Deposits Extent: **Medium**
